Manhole Inspection Summary

Manhole # S35MM1004MH

Insp Date: **3/13/07 3:10 PM**

Location Address: **4504 EASTWAY**

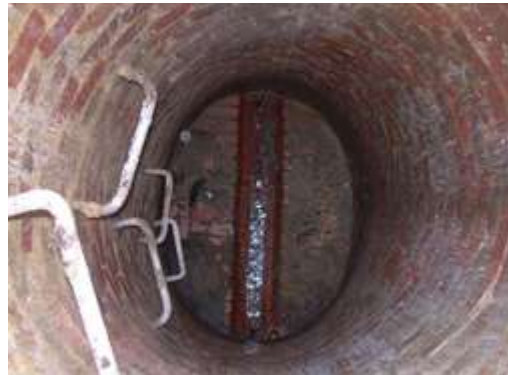
Top View

Evidence of surcharge - Bench debris.

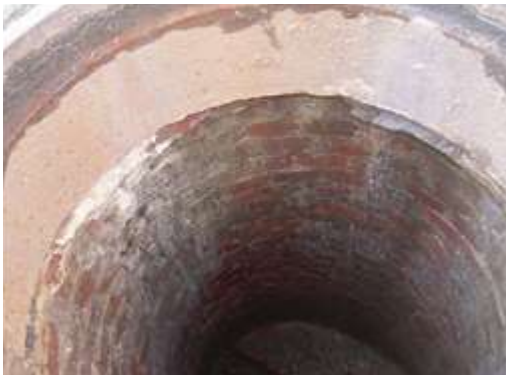
Defect

☒ **Leaks**

Condition: ☐ Sound ☐ Cracked ☐ Root Intrusion ☐ Loose Brick ☒ **Deteriorated**

Infiltration: ☐ None ☒ **Joint** ☐ Cracks ☐ Mortar ☐ Roots ☒ **Wall**

Infiltration: ☐ None ☐ Joint ☐ Cracks ☐ Mortar ☐ Roots ☒ **Wall**

Frame leaks. Adjustment deterioration and infiltration. Barrel infiltration.

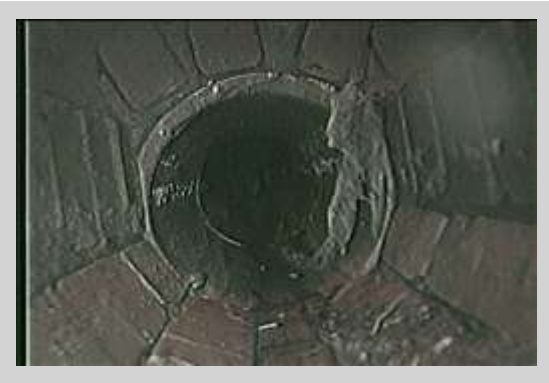
8 in. Circular Gravity Sewer Pipe Out @ 12 O'Clock

Condition: ☐ Sound ☐ Cracked ☐ Root Intrusion ☒ **Deteriorated** ☐ Leaks ☐ Debris

Channel deterioration.

Infiltration: **Evidence** Pipe Seal Cond: **Roots**

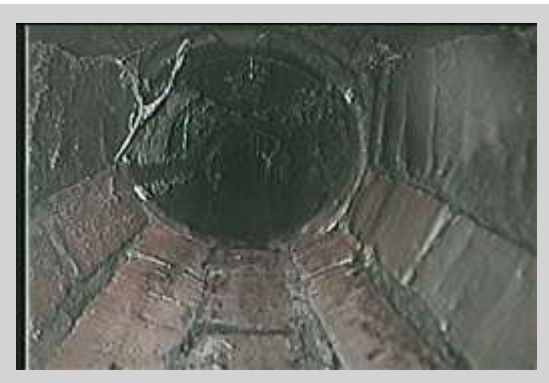
8 in. Circular Gravity Sewer Pipe In @ 6 O'Clock

Deposits: ☐ None ☐ Mud ☐ Sludge ☐ Debris ☒ Grease

Infiltration: **Evidence** Pipe Seal Cond: **Cracked**
